6.4 MECHANICAL, ELECTRICAL, AND PLUMBING COMPONENTS

6.4.9 LIGHT FIXTURES

6.4.9.3 PENDANT LIGHT FIXTURES

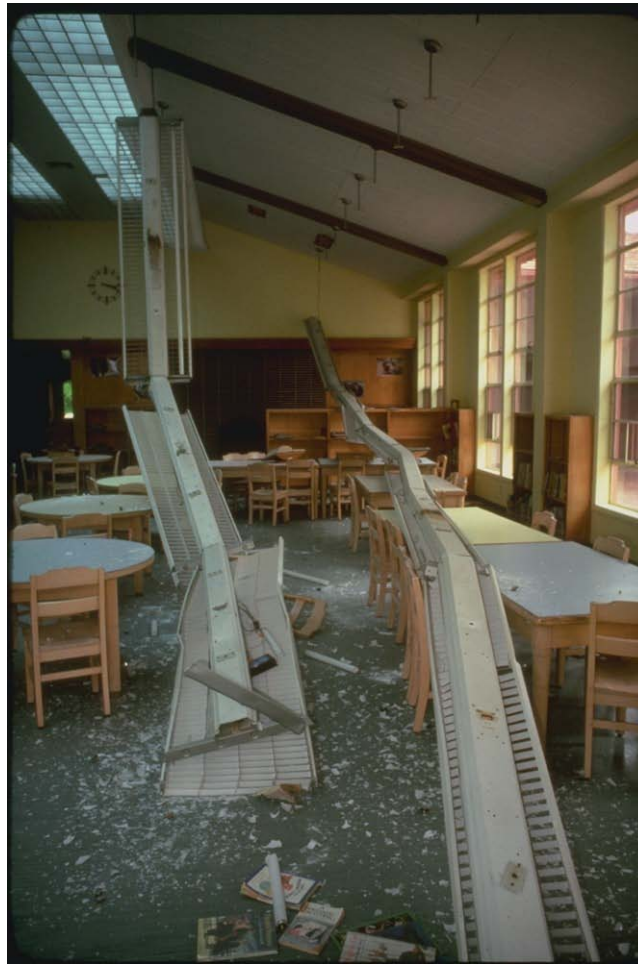
Figure 6.4.9.3-2 Failure of pendant light fixtures at Northridge Junior High School as a result of the 1994 Northridge Earthquake. In this example, the support stem failed at the fixture connection and the stem is still attached at the ceiling (Photo courtesy of Gary L. McGavin).

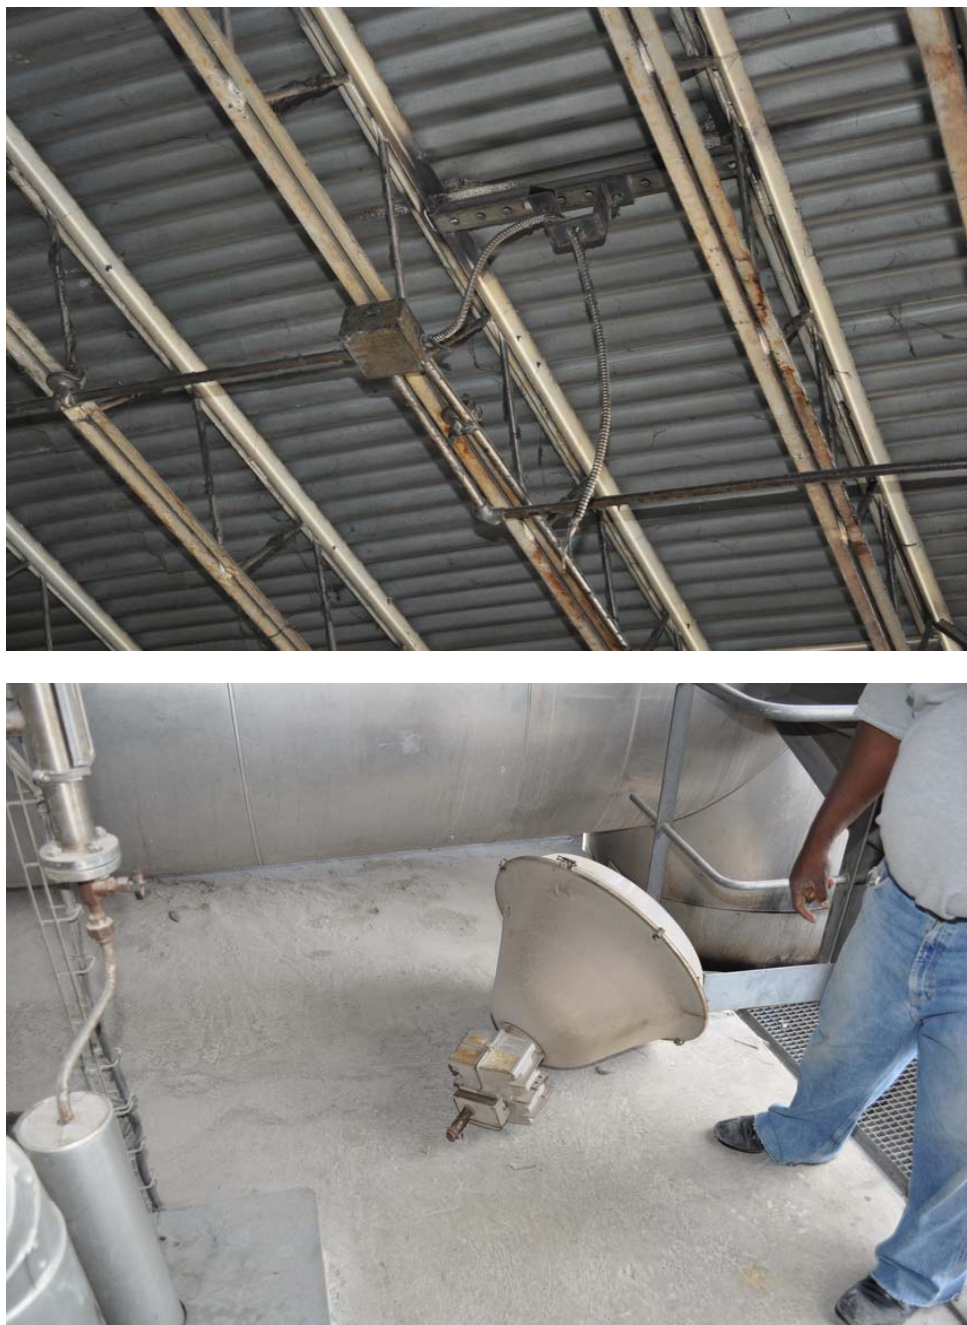
Figure 6.4.9.3-3 Failure of pendant light fixture in the 2010 magnitude-7 Haiti Earthquake; stem of fixture broke and conduit pulled loose (Photos courtesy of Eduardo Fierro, BFP Engineers).

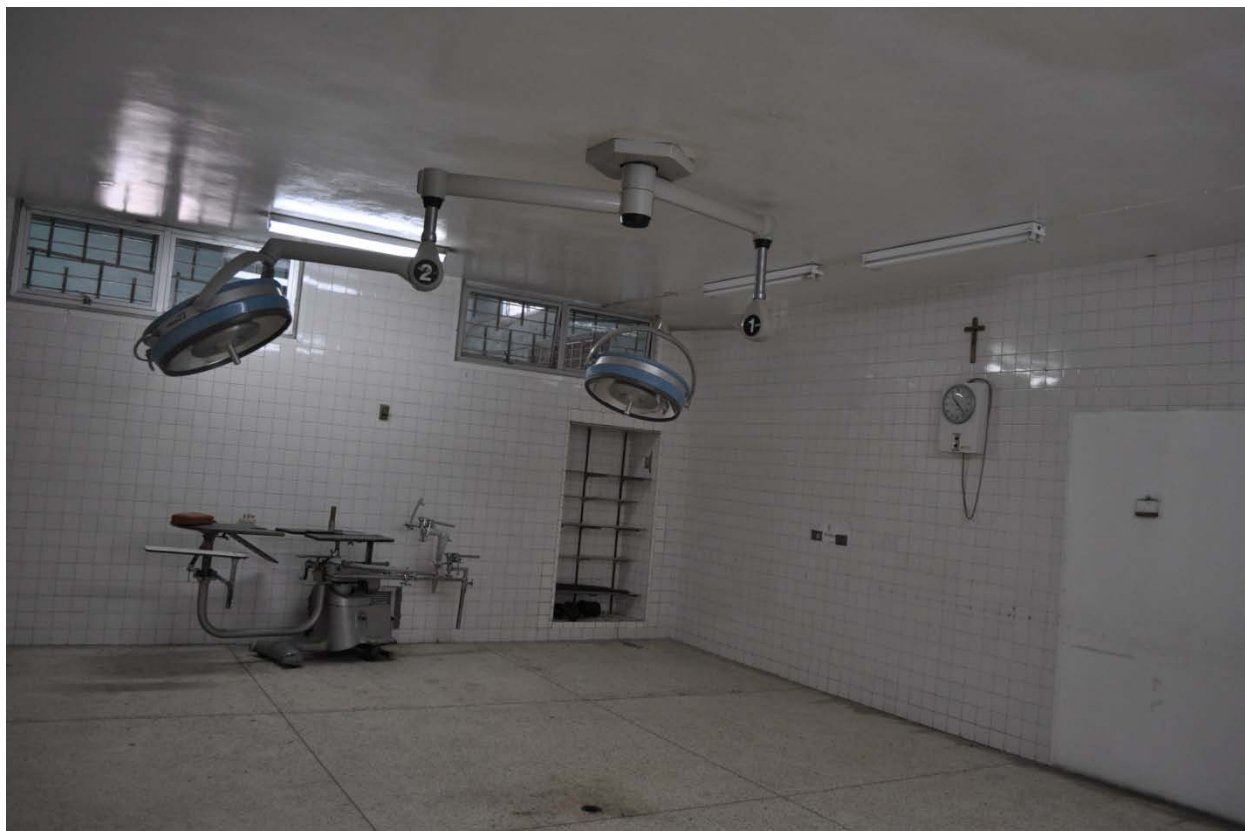
Figure 6.4.9.4-1 Operating room lights undamaged although hospital evacuated due to collapse of adjacent wing in the 2010 magnitude-7 Haiti Earthquake. Fixture anchored to underside of concrete slab (Photo courtesy of Ayhan Irfanoglu, Purdue University).

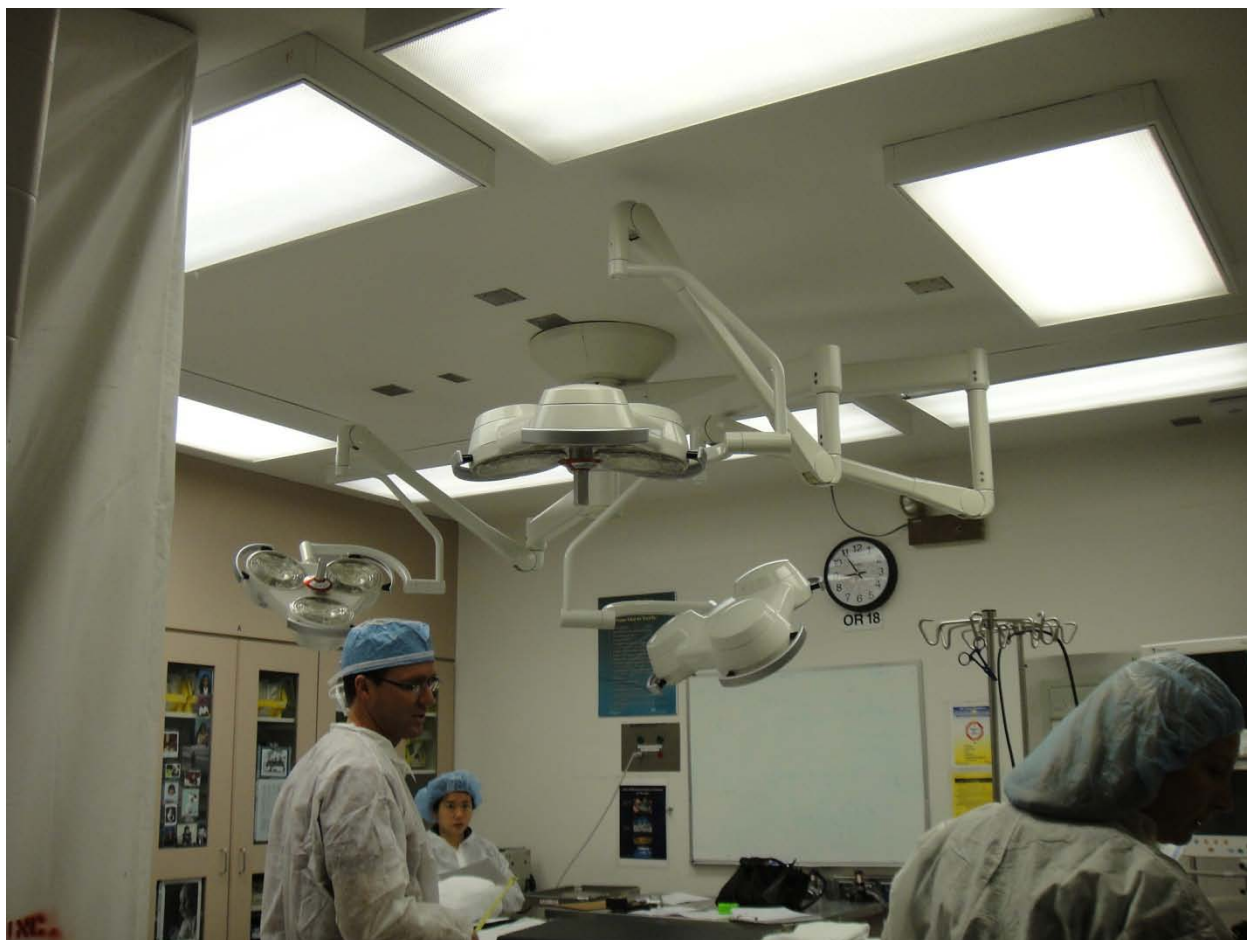
Figure 6.4.9.4-2

Engineered support and bracing are required for heavy operating room lights. The arms, joints, lenses and bulbs must be capable of resisting seismic forces. Hospital fixtures require certification. Photo also shows surface mounted fluorescent fixtures in a suspended gypsum board ceiling; each of these requires independent safety wires to the structure above; see Section 6.4.9.2 (Photo courtesy of Maryann Phipps, Estructure).

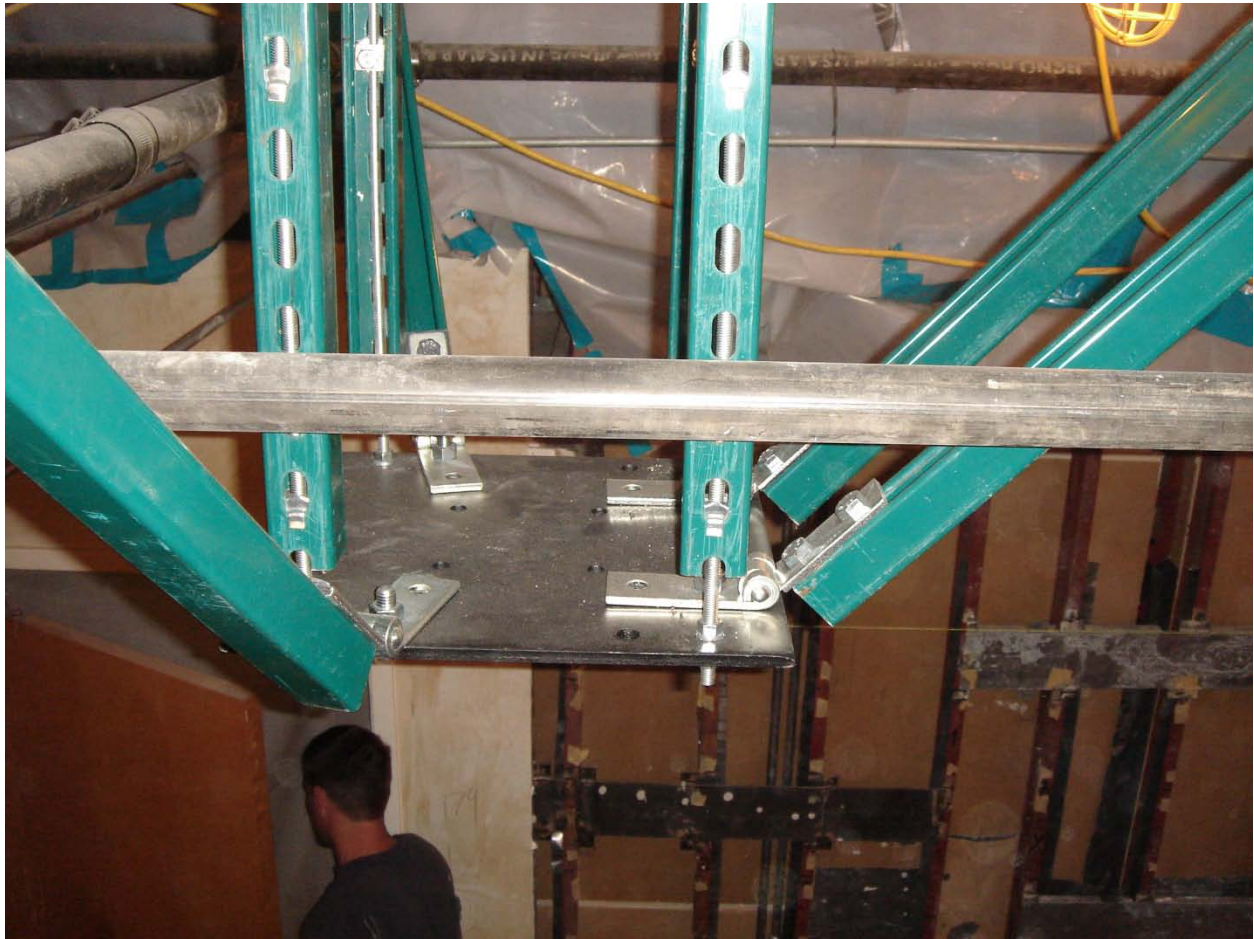
Figure 6.4.9.4-3 Engineered support and bracing for operating room lights located in California hospital. Steel plate has predrilled holes to receive fixture attachments (Photo courtesy of Maryann Phipps, Estructure).

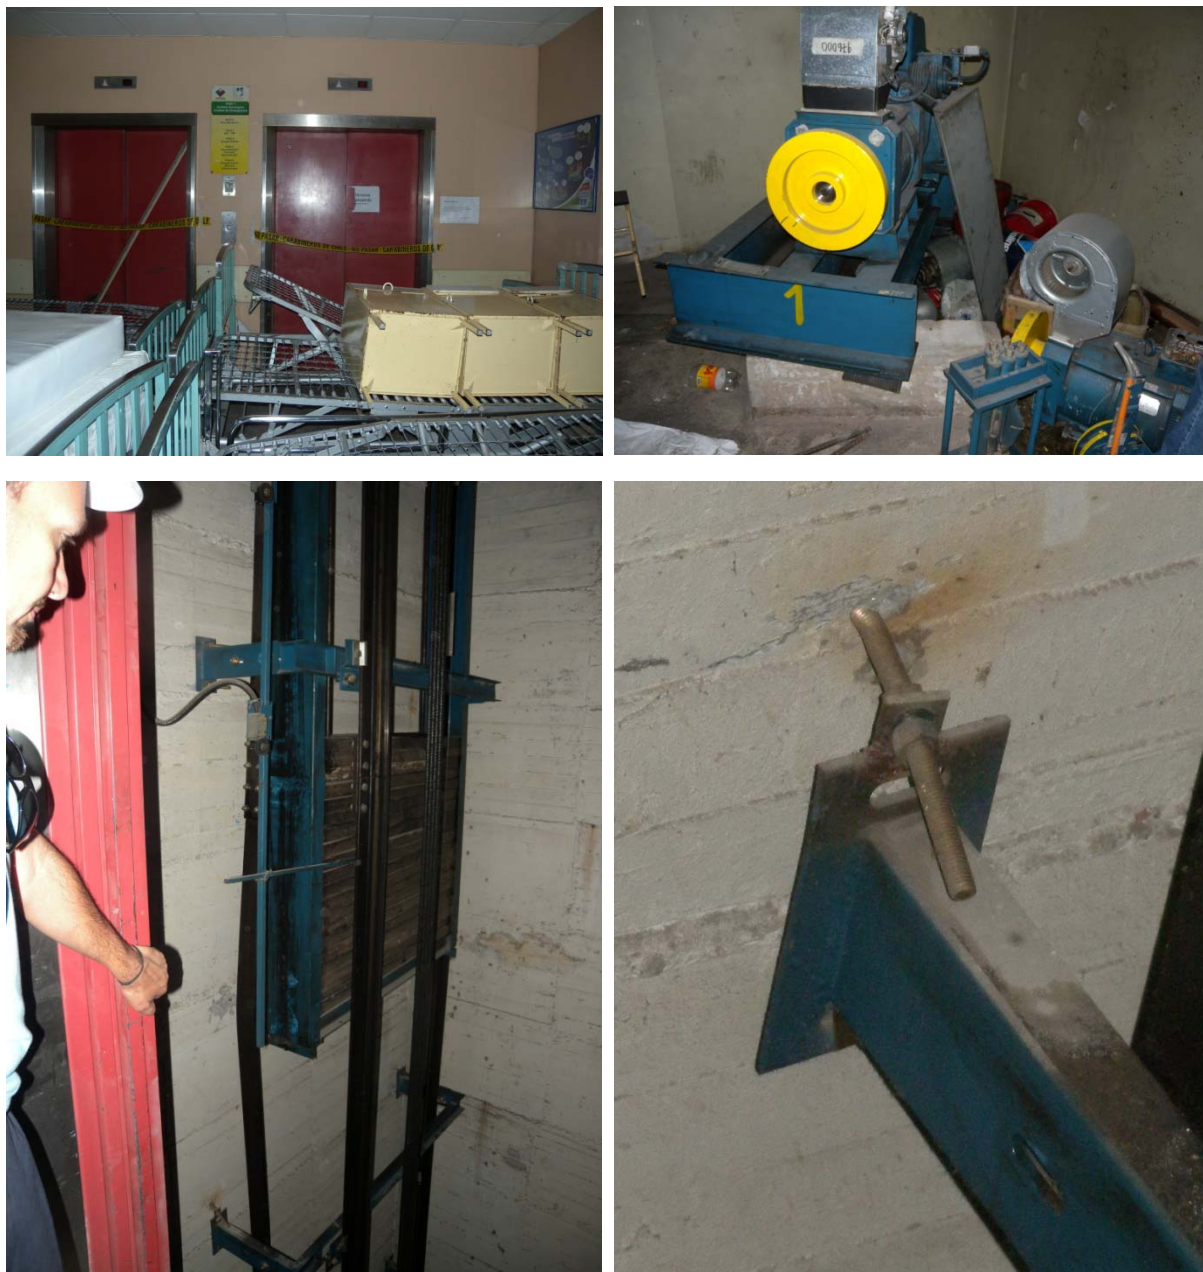
Figure 6.4.10.2-1 Damage to traction elevator in Chillán in the 2010 magnitude-8.8 Chile Earthquake (Photo courtesy of Gilberto Mosqueda, SUNY Buffalo). The unanchored sheaves and motor above the 6th floor slid nearly off the housekeeping pad. The counterweight guide rails are bent due to impact with the counterweights. The guide rail support brackets have horizontal slots, but the bolt went through a welded tab (photo at lower right) and pulled out of the wall.

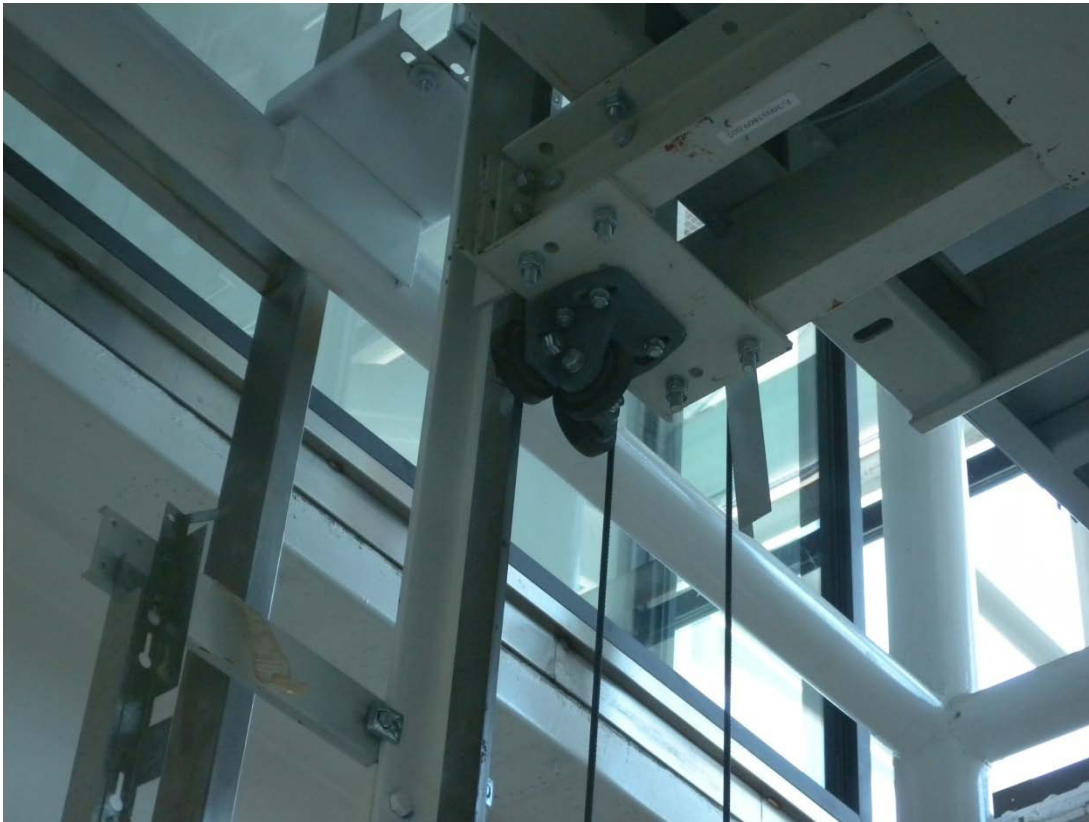
Figure 6.4.10.2-2 Derailed car roller assembly of the guide rail at the Santiago airport in the 2010 Chile Earthquake (Photo courtesy of Gilberto Mosqueda, SUNY Buffalo). The three rollers are supposed to travel along three sides of the stem of the T-shaped steel guide rail.

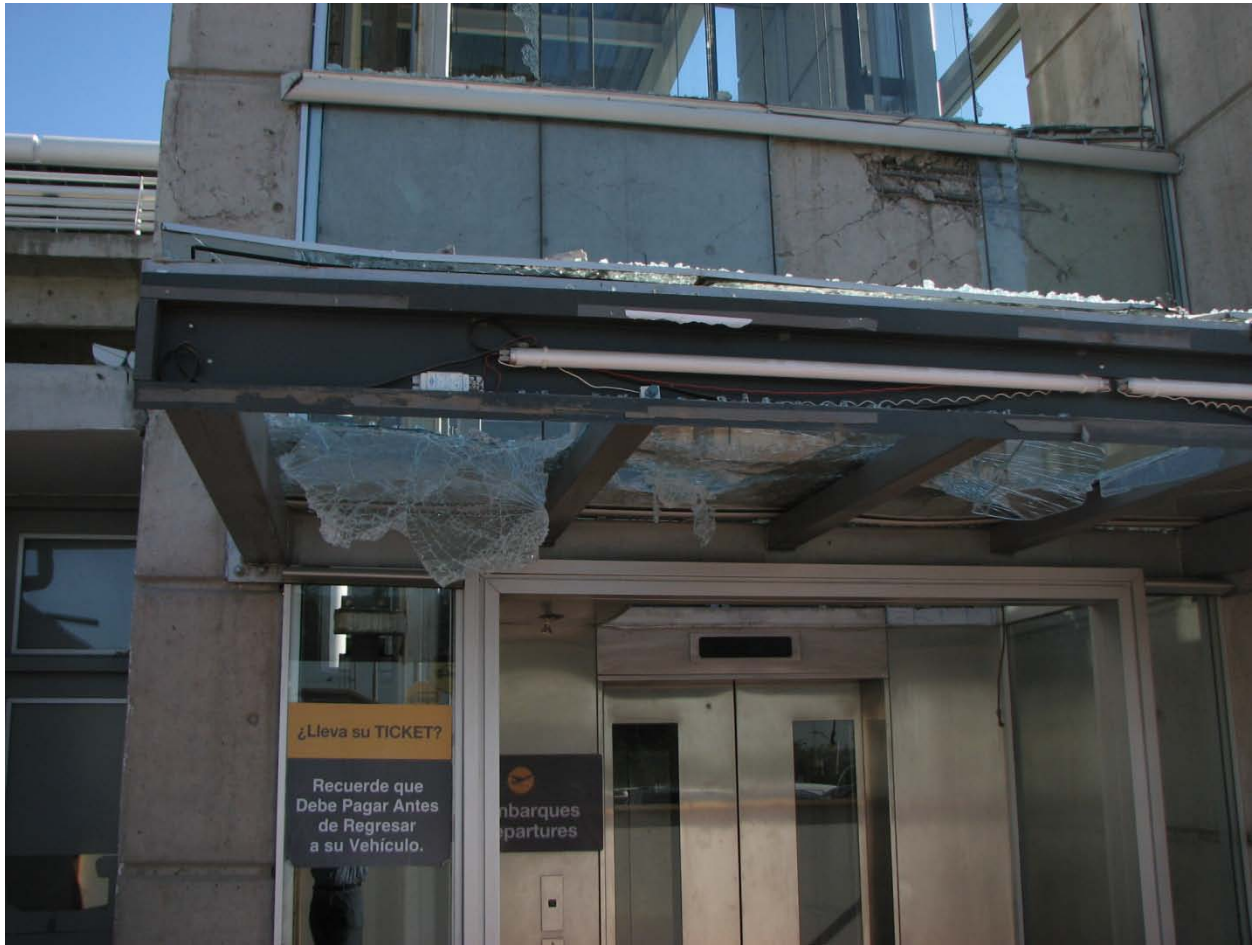
Figure 6.4.10.2-3 Glazing failures caused additional hazards at Santiago airport elevator in the 2010 Chile Earthquake (Photo courtesy of Antonio Iruretagoyena, Rubén Borsochek & Associates).

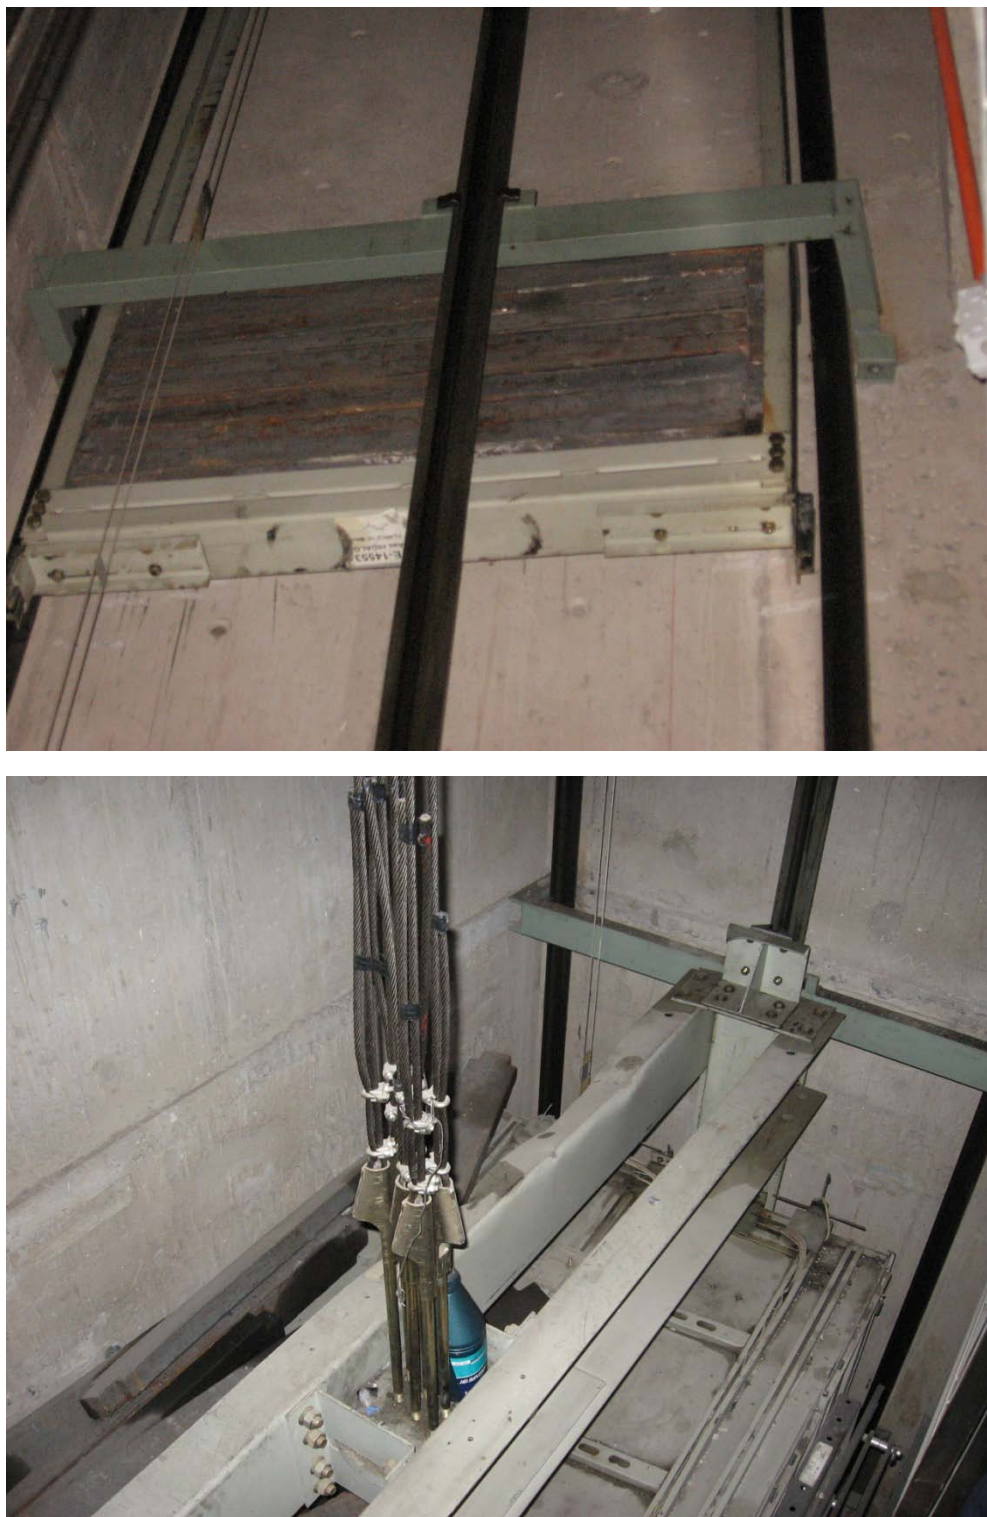
Figure 6.4.10.2-4 Unrestrained movement of the counterweights damaged the counterweight assembly and bent the counterweight guide rails; over half the subweights dropped onto the top of the cab and damaged the cab framing in the 2010 Chile Earthquake (Photo courtesy of Rodrigo Retamales, Rubén Borsochek & Associates).

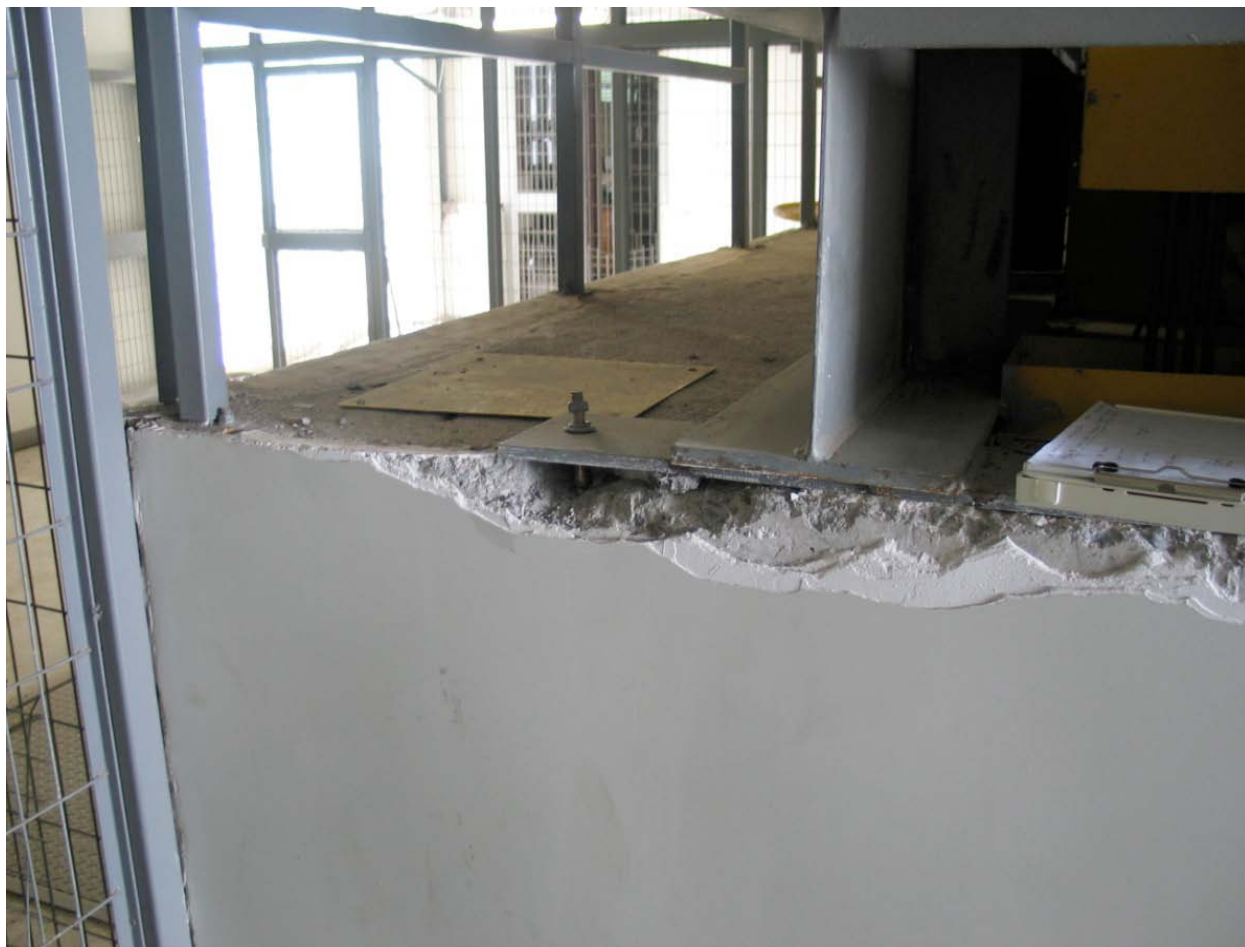
Figure 6.4.10.2-5 Anchor bolt failure of the elevator generator set due to inadequate edge distance for the bolts at the Los Angeles Regional Public Hospital in the 2010 Chile Earthquake (Photo courtesy of Bill Holmes, Rutherford & Chekene).

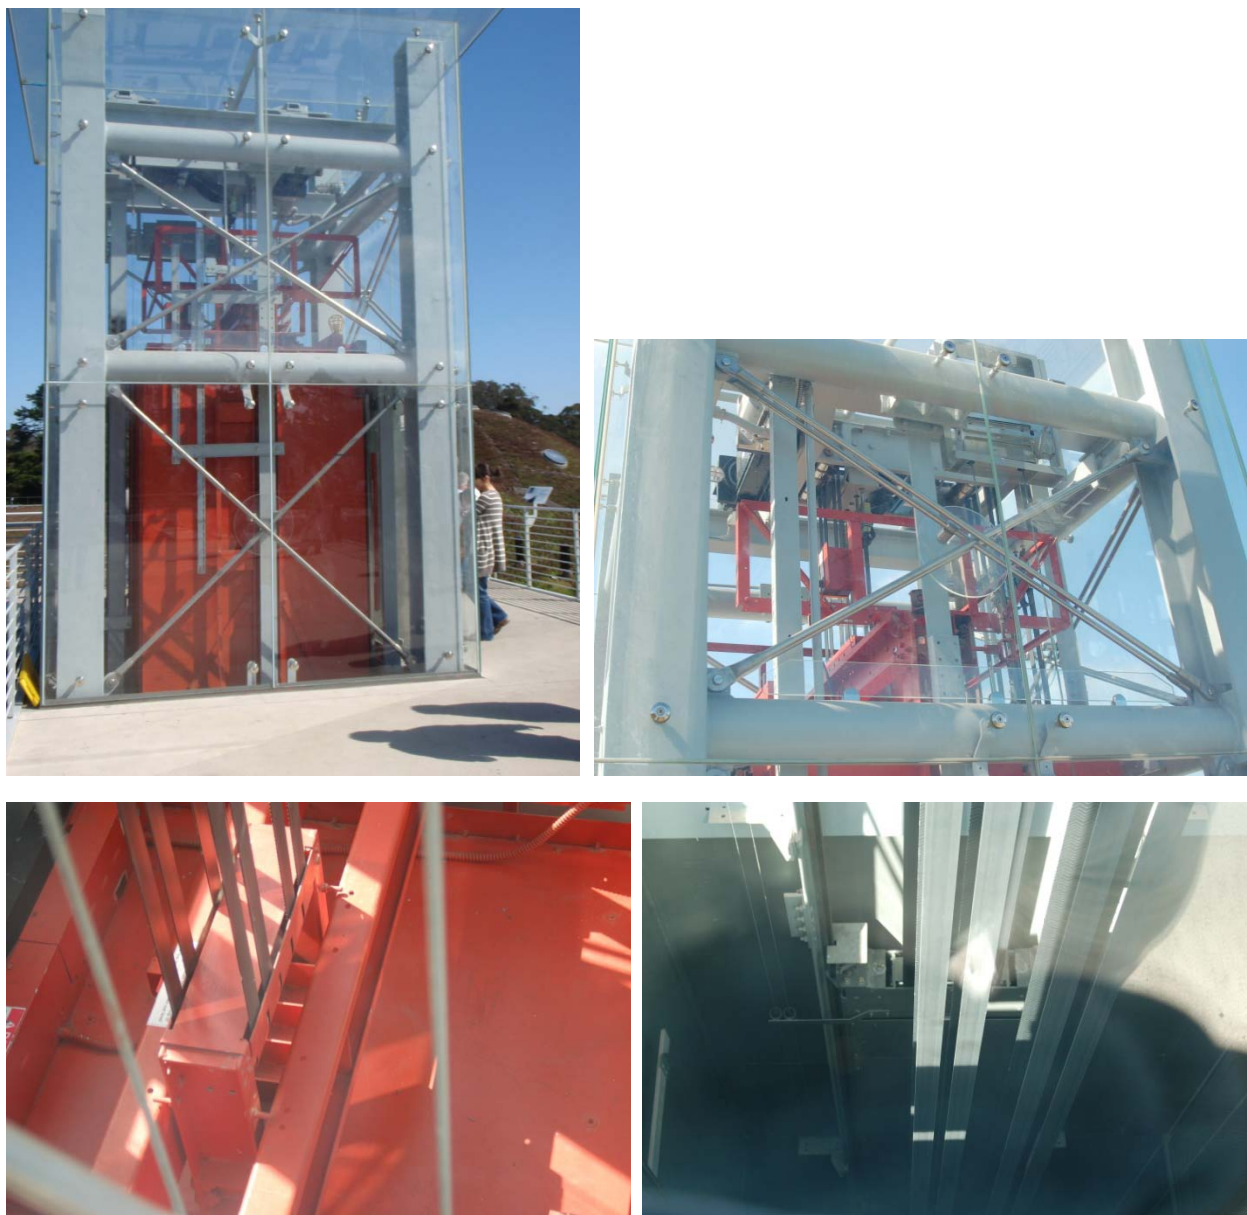
Figure 6.4.10.2-6 Small “machine-roomless” traction elevator with flat belts at the Academy of Sciences, San Francisco, California (Photos courtesy of Eduardo Fierro, BFP Engineers). Clockwise: Overview of elevator at roof; view of guide rails and sheaves; top of cab showing belts; view down shaft at belts, counterweight, guide rails and guide rail brackets.

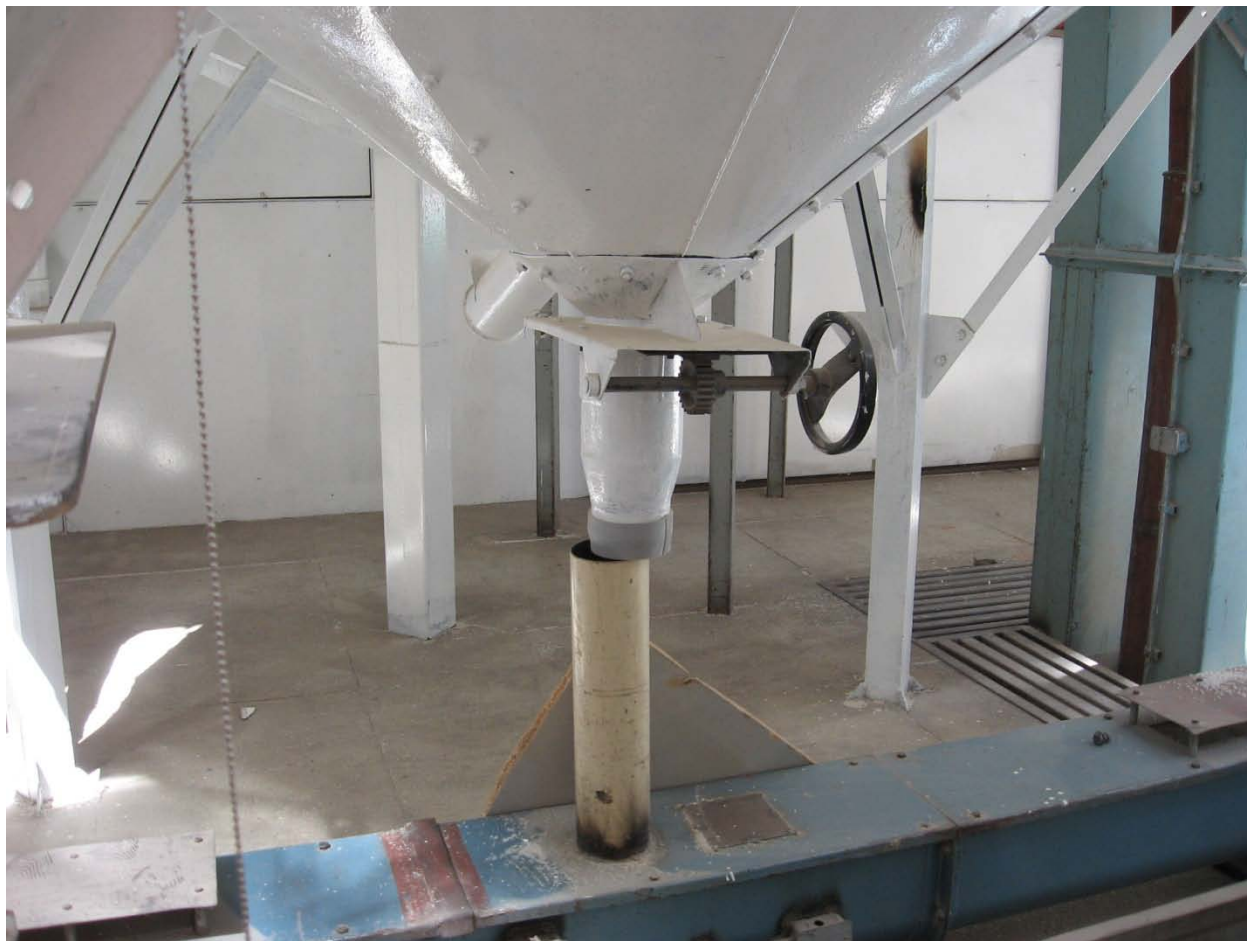
Figure 6.4.11.1-1 Misalignment between rice storage hopper and conveyor following the 2010 magnitude-8.8 Chile Earthquake (Photo courtesy of Rodrigo Retamales, Rubén Boroschek & Associates). Where various system components interface with a conveyor, the seismic restraints for the various parts should be coordinated to maintain alignment following an earthquake.

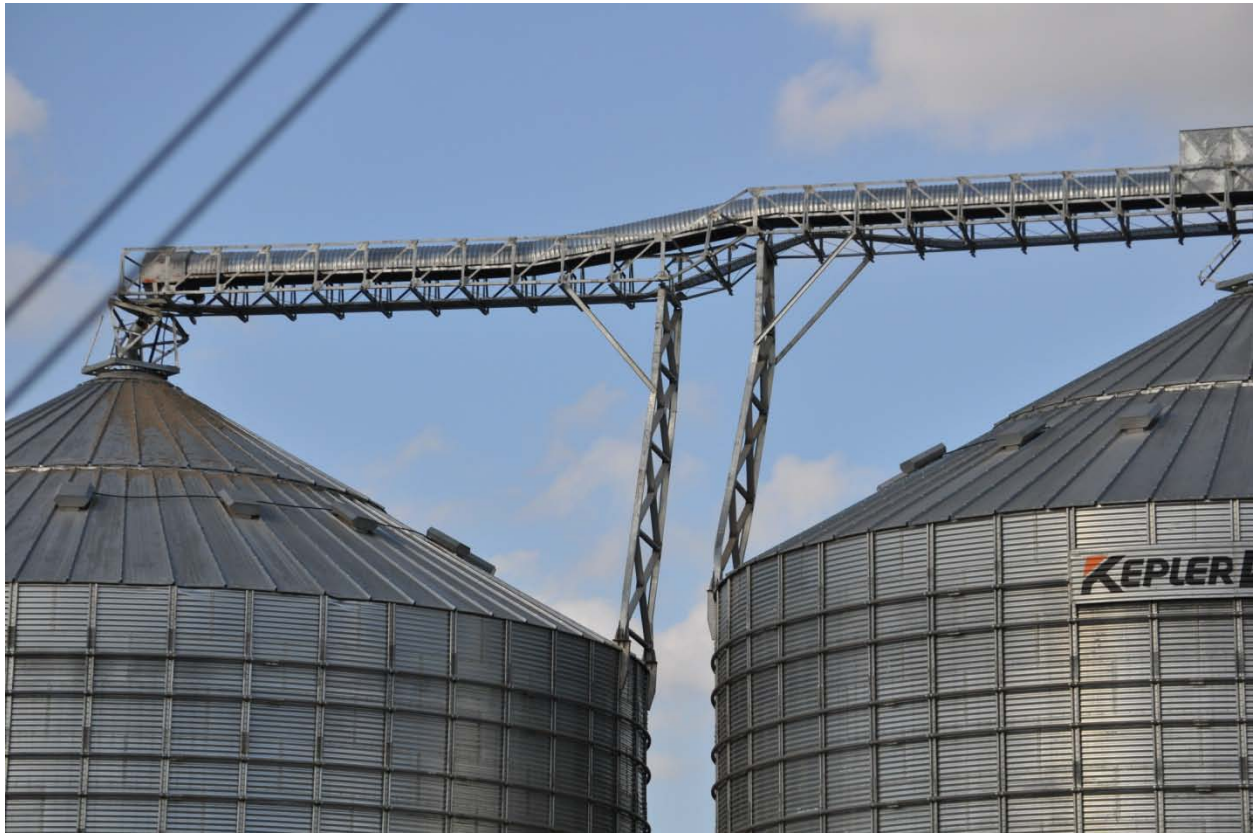
Figure 6.4.11.1-2 Damage to industrial conveyor used to feed grain silos in the 2010 Chile Earthquake (Photo courtesy of Eduardo Fierro, BFP Engineers).

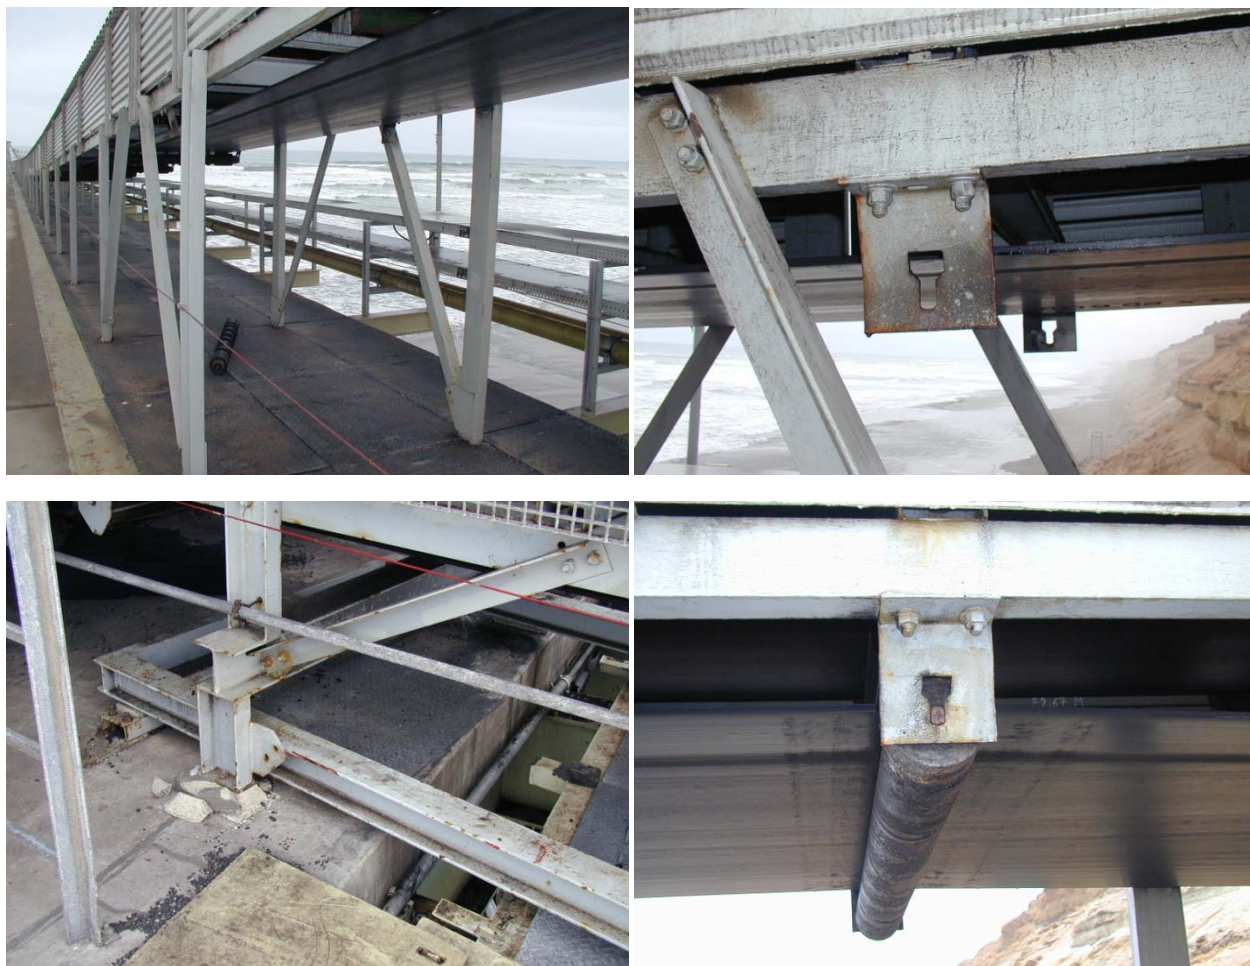
Figure 6.4.11.1-3 Damage to industrial coal conveyor on jetty in southern Peru in the 2001 magnitude-8.4 Peru Earthquake (Photos courtesy of Eduardo Fierro, BFP Engineers). Conveyor was well anchored along entire length but detailing at the seismic joint between the jetty and platform did not allow sufficient movement, resulting in misalignment at end of conveyor and damage to the supports as shown at lower left. Approximately 10% of the rollers fell; these were held in place with friction fittings and did not have positive connections.

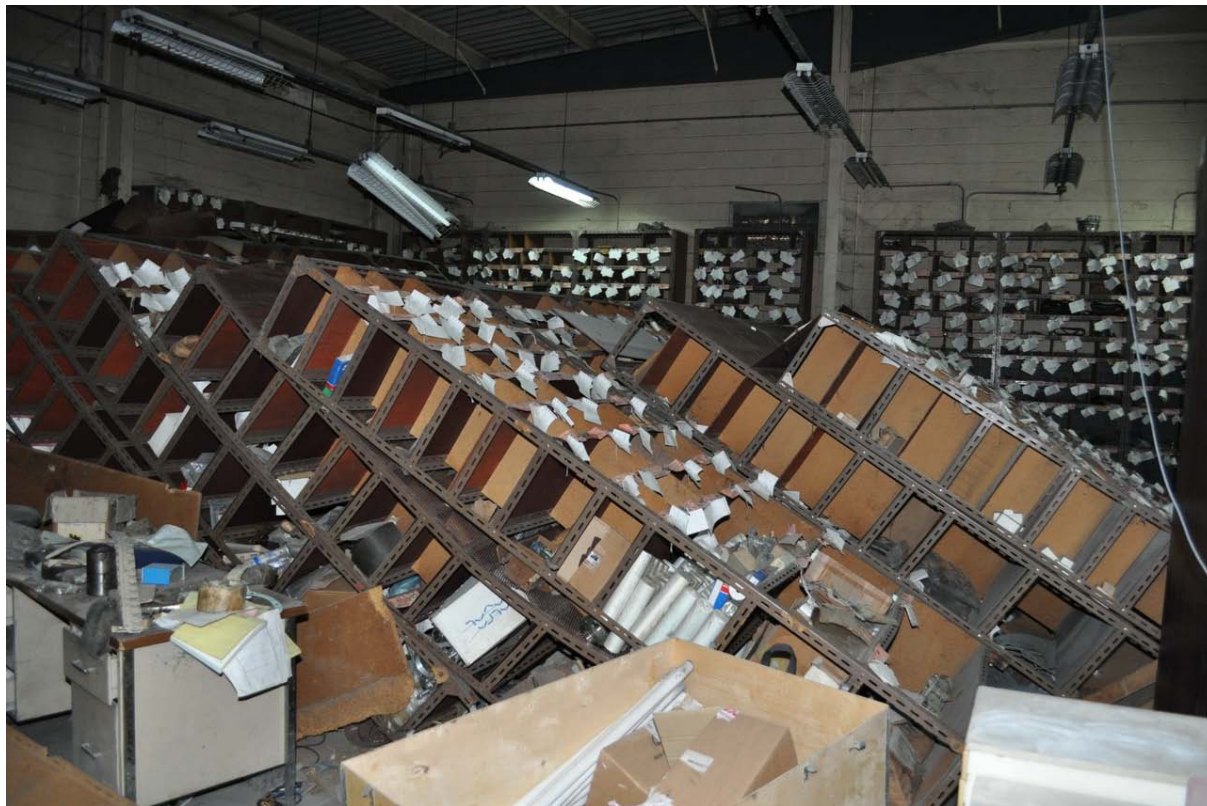
Figure 6.5.1.1-1 Collapse of row of unanchored freestanding shelving units containing spare parts at an electric power plant in Port-au-Prince in the 2010 magnitude-7 Haiti Earthquake (Photo courtesy of Eduardo Fierro, BFP Engineers).

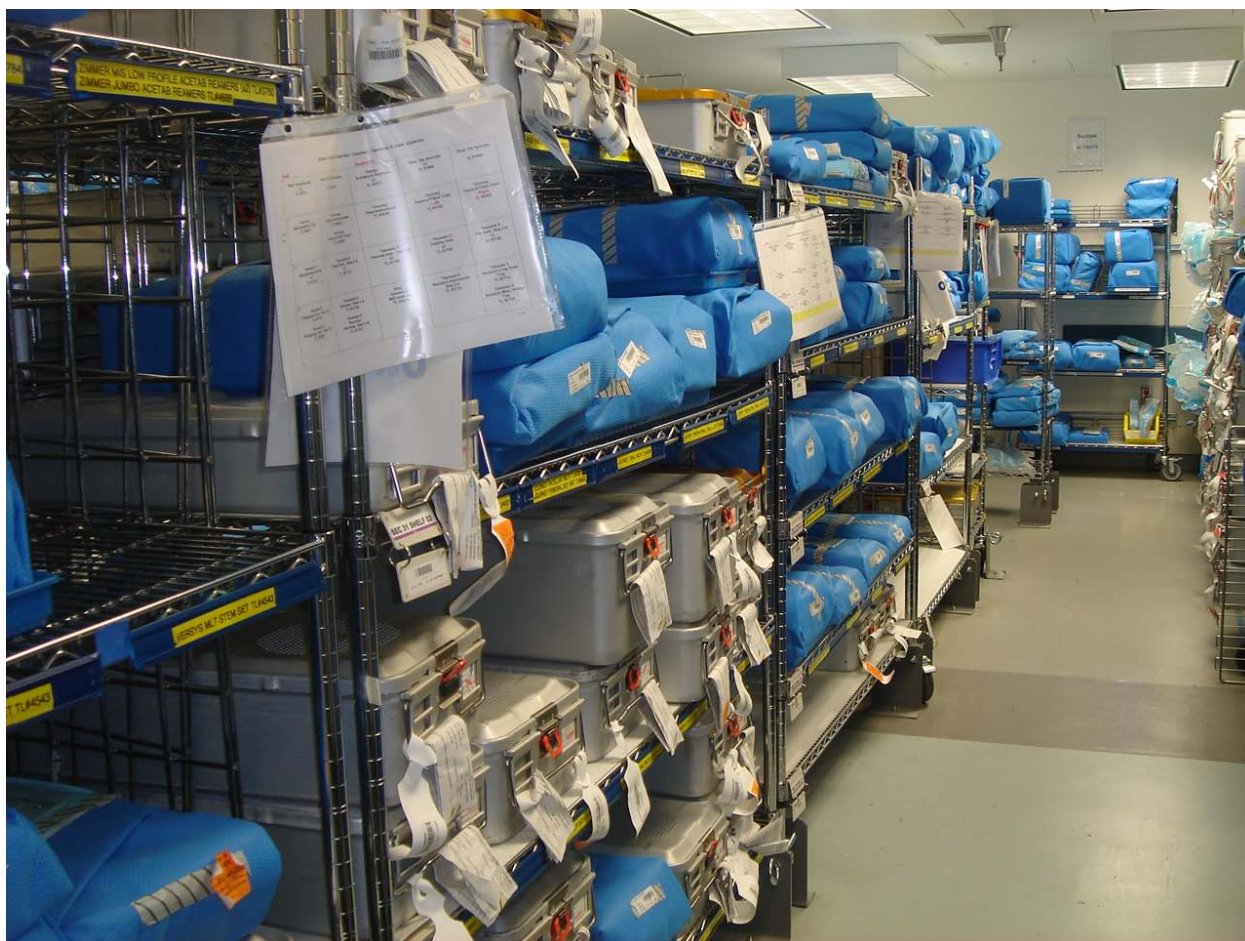
Figure 6.5.1.1-3 Mobile carts restrained at base with clip angles anchored to the floor and removable eyebolts attached from each cart to the angles (Photo courtesy of Maryann Phipps, Estructure).

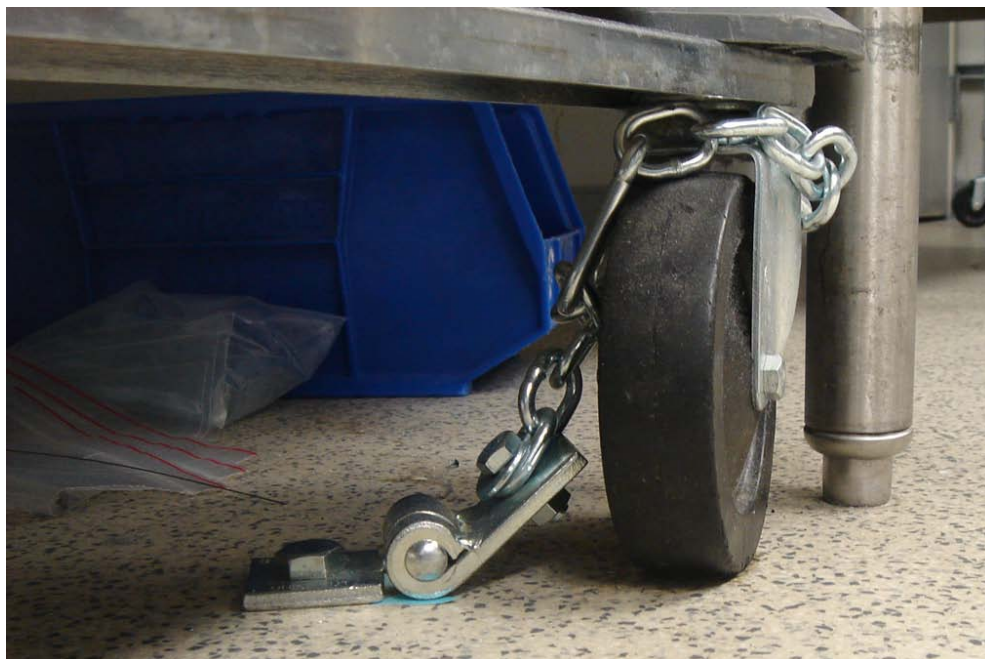
Figure 6.5.1.1-4 Alternate restraint at base of mobile shelving unit (Photo courtesy of Maryann Phipps, Estructure).

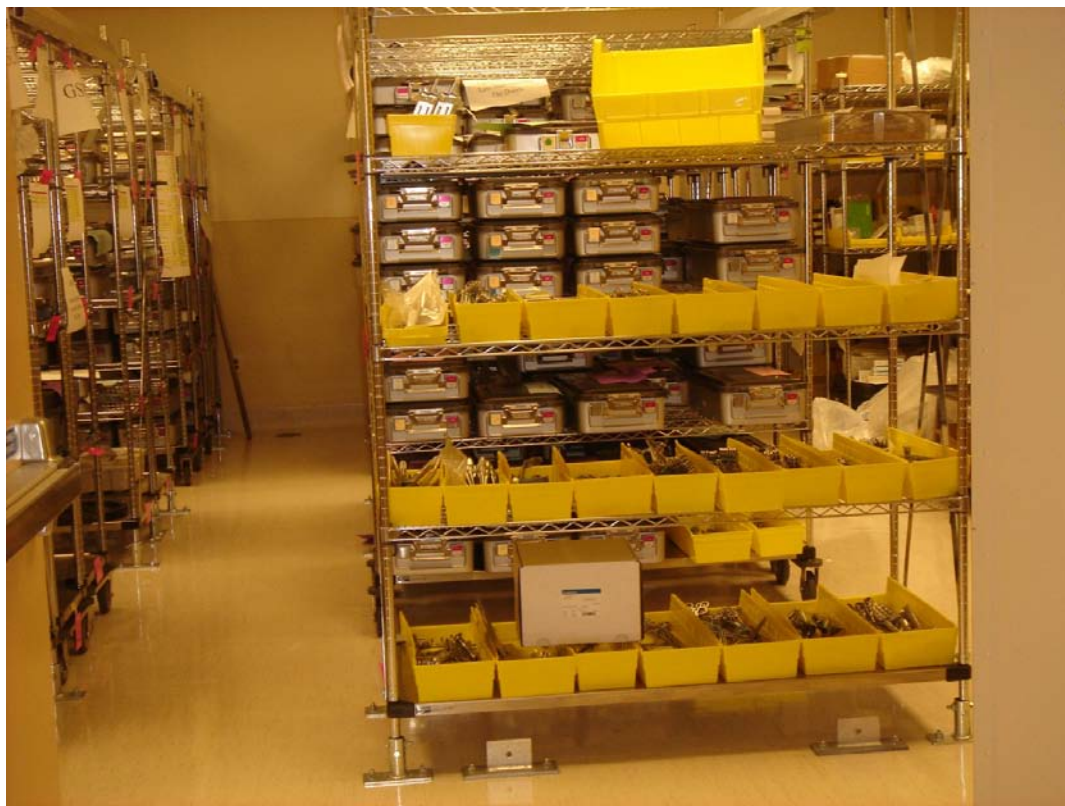
Figure 6.5.1.1-5 Fixed base shelving units anchored with optional seismic base plate offered by manufacturer (Photo courtesy of Maryann Phipps, Estructure).

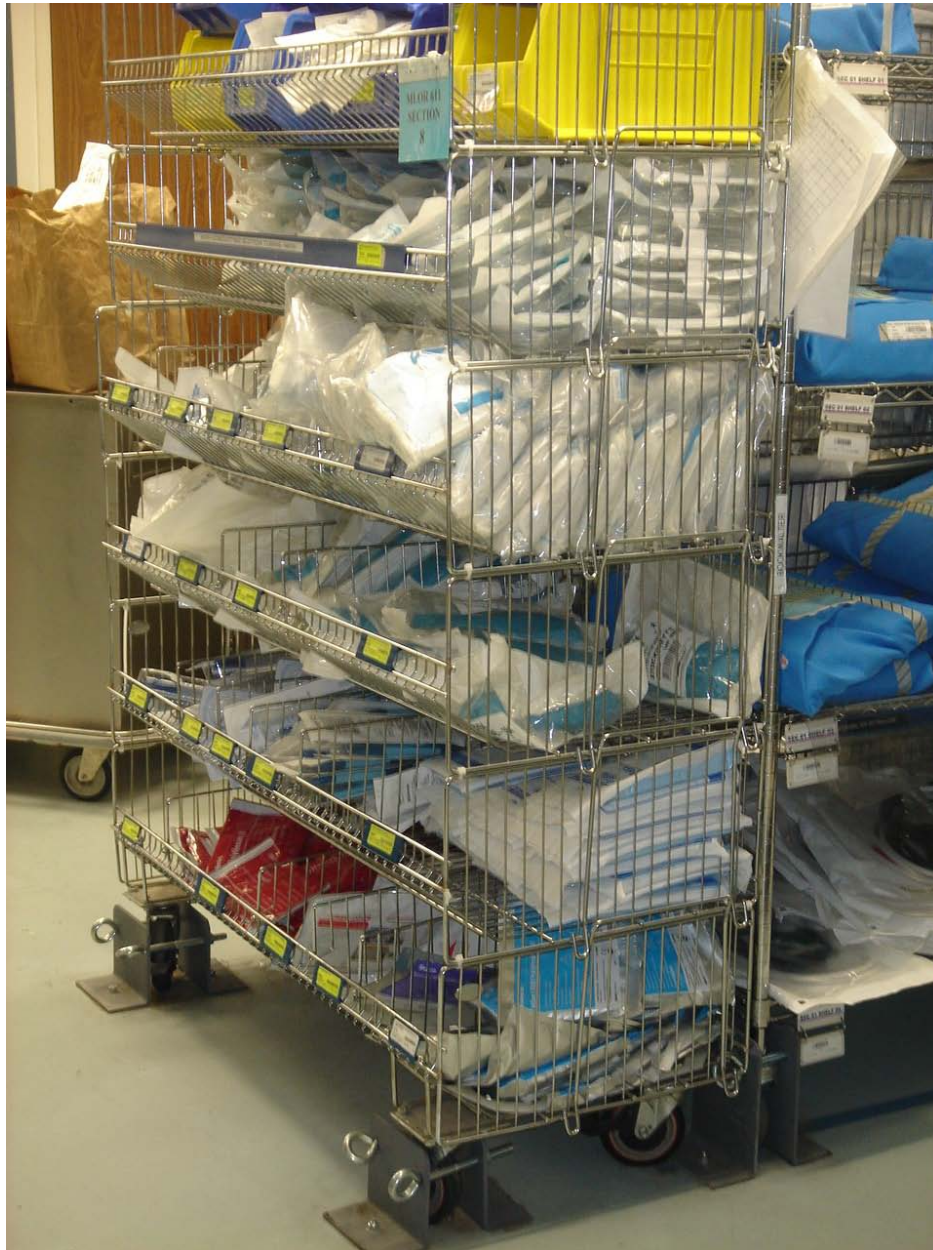
Figure 6.5.1.1-6 Mobile cart restrained at base with removable angles and eyebolts. Back-to-back units are interconnected (Photo courtesy of Maryann Phipps, Estructure).
